# ACCIDENTS AND INCIDENTS 2009

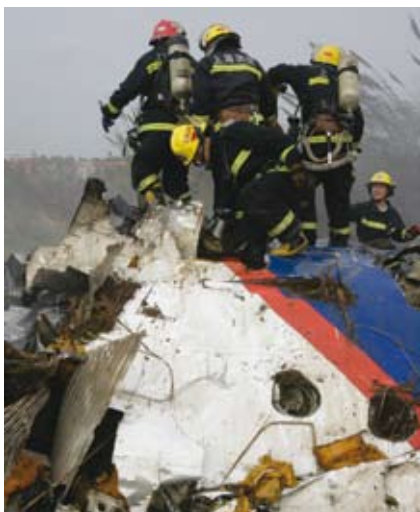
**Clockwise from top left: the Avient MD-11F Shanghai accident; the Colgan-flown Continental Connection crash; ferries surround the ditched US Airways A320; wreckage from the Air France A330**

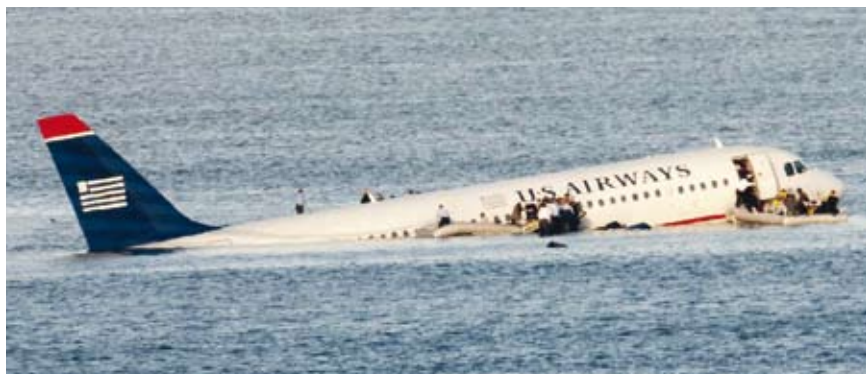
Date	Carrier	Aircraft type/registration	Location	Injuries crew/pax	Total occupants crew/pax	Phase
<b>SIGNIFICANT NON-FATAL ACCIDENTS</b>						
<b>15 January</b>	<b>US Airways</b>	<b>Airbus A320-200 (N106US)</b>	Hudson river, New York, USA	-/-	5/150	C
At 3,000ft, climbing out of New York La Guardia airport, the aircraft flew through a flock of Canada geese and the engines lost power. The captain's initial reaction was to return, but he rejected that idea along with the possibility of heading for Teterboro airport, and advised New York Traccon that he would ditch in the Hudson river. The ditching on a calm surface caused a hull breach in the aft belly, but the airframe came to a halt substantially undamaged, and floated. The passengers evacuated onto the wings and escape slides and were picked up rapidly by boats.						
<b>27 January</b>	<b>Empire Airlines</b>	<b>ATR 42-300 (N902FX)</b>	Lubbock, Texas, USA	2	2	RA
